Technical Report – R4791475629-1 BS 6375-1:2015+A1:2016- Performance of Windows & Doors, Classification and Guidance for Weather Tightness

**Gretsch Unitas Ltd
Composite Door with GU Secury LogIQ
Automatic Hardware**

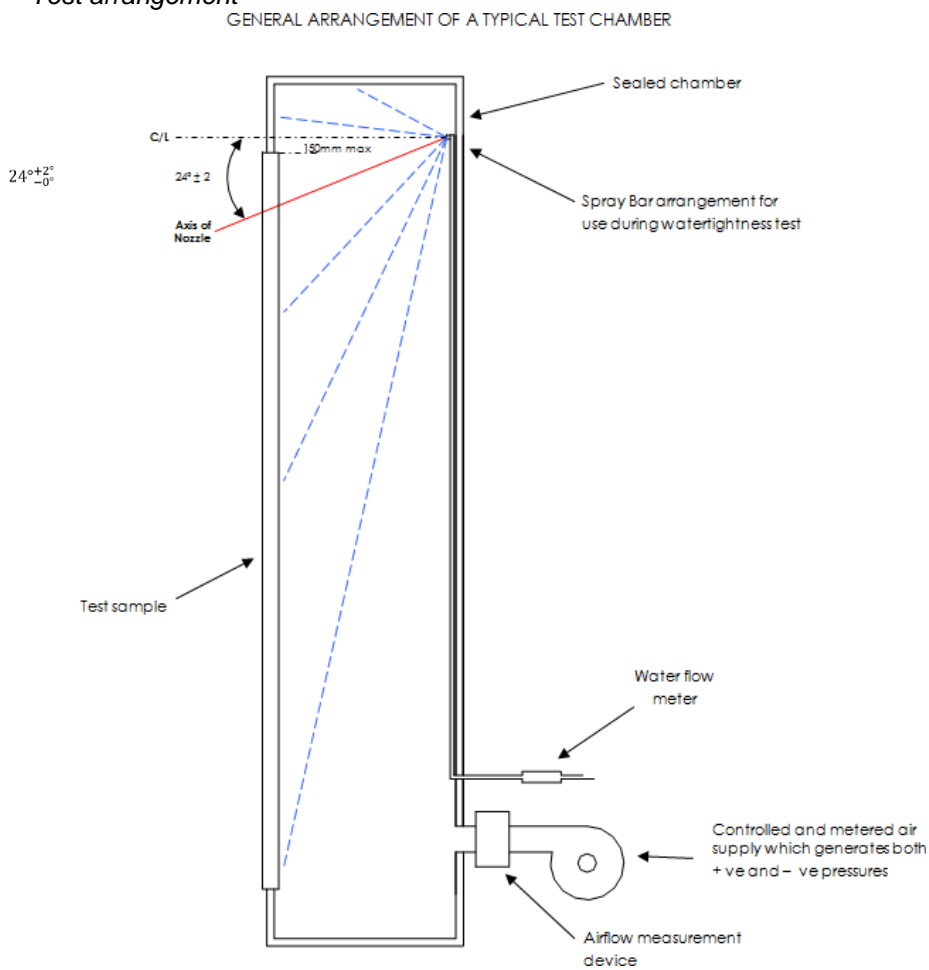
Figure 1 – Test arrangement

A window specimen, supplied for testing in accordance with the relevant British and European Standards, was mounted into a rigid test chamber. The pressure within the chamber was controlled by means of a centrifugal fan and a system of ducting and valves. The static pressure difference between the outside and inside of the chamber being measured by means of a pressure transmitter.

The spray nozzles have a circular full cone spray pattern and a spray angle of $120^\circ (+0^\circ/-10^\circ)$ at working pressure of 2 – 3 bar and a flow rate of 2 litres/min (± 0.2 litres/min) per nozzle. The nozzles were spaced at 400 mm (± 10 mm) along the axis of the spraybar and the nozzles were arranged so that the lateral distance between the outer edge of the surround and the outermost nozzles shall be greater than 50mm but not exceeding 250mm.

The nozzle line was located not more than 150mm above the topmost horizontal joint line of any moving frame or the glazing line of any fixed glazing, to provide complete wetting of the adjacent horizontal frame member(s). The nozzle line was also located at 250mm ($+10$ mm/ -0 mm) from the external face of the specimen as defined by the outermost external joint plane of moving parts or the glazing plane of fixed parts.

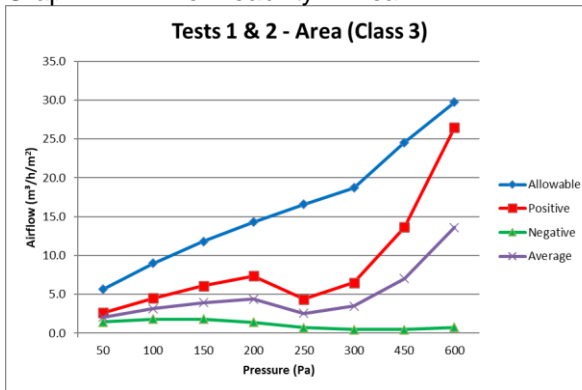
Graph 1 – Air Permeability – Area

Pressure Differential Pa	Air Permeability Rate Infiltration & Exfiltration Tests m ³ /hr/m ² - Area			Air Permeability Rate Infiltration & Exfiltration Tests m ³ /hr/m - Length of Joint		
	Test No. 1 (Positive)	Test No. 2 (Negative)	Average	Test No. 1 (Positive)	Test No. 2 (Negative)	Average
50	2.63	1.45	2.04	0.97	0.54	0.76
100	4.50	1.83	3.16	1.67	0.68	1.17
150	6.11	1.80	3.95	2.26	0.67	1.46
200	7.36	1.40	4.38	2.72	0.52	1.62
250	4.37	0.73	2.55	1.62	0.27	0.94
300	6.50	0.46	3.48	2.41	0.17	1.29
450	13.66	0.46	7.06	5.06	0.17	2.61
600	26.46	0.75	13.60	9.80	0.28	5.04

Based on Area	Based on Length of Opening Joint
3	3
Overall Class	
3

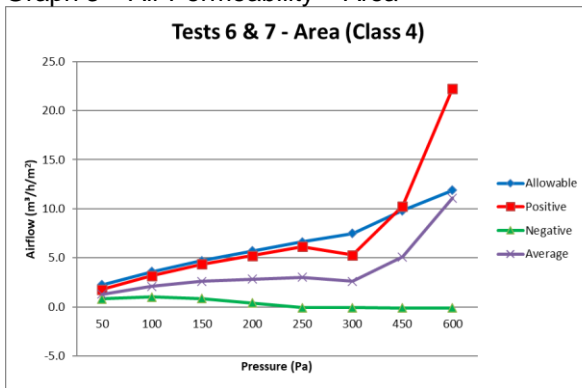
Graph 3 – Air Permeability – Area

Pressure Differential Pa	Air Permeability Rate Infiltration & Exfiltration Tests m ³ /hr/m ² - Area			Air Permeability Rate Infiltration & Exfiltration Tests m ³ /hr/m - Length of Joint		
	Test No. 6 (Positive)	Test No. 7 (Negative)	Average	Test No. 6 (Positive)	Test No. 7 (Negative)	Average
50	1.79	0.83	1.31	0.66	0.31	0.48
100	3.20	1.02	2.11	1.18	0.38	0.78
150	4.36	0.87	2.61	1.61	0.32	0.97
200	5.23	0.40	2.82	1.94	0.15	1.04
250	6.15	0.00	3.03	2.27	0.00	1.12
300	5.28	0.00	2.60	1.96	0.00	0.96
450	10.27	0.00	5.09	3.80	0.00	1.88
600	22.26	0.00	11.08	8.24	0.00	4.10

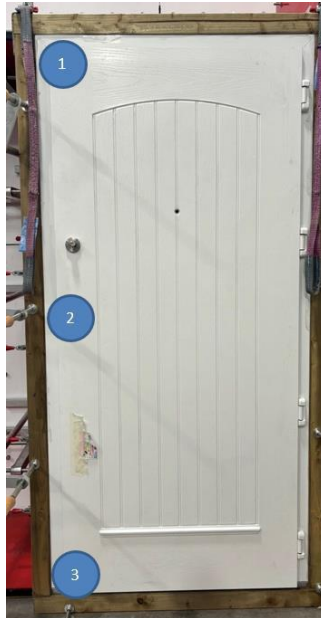
Figure 2 – Position of deflection measurement sensors

$$\text{Deflection} = [\text{measurement recorded by probe at location 'lx'}] l_2 - \left(\frac{l_3 - l_1}{2}\right)$$

Member Under Test	Test Pressure Pa	Maximum Deflection mm	Residual Deformation mm	Deflection Class	Relative Frontal Deflection
Member A	800	0.5	0.0	Class C	1/4447
	-800	0.4	0.0	Class C	1/5002

Deflection measurement devices with an accuracy of $\pm 5\%$ were used to measure deflection of principle framing members. These measurement devices were mounted at mid span and as near to the supports of the members and located in such a way that any measurement was not influenced by the application of any loading to the sample. The gauges were mounted as shown in Figure 2.

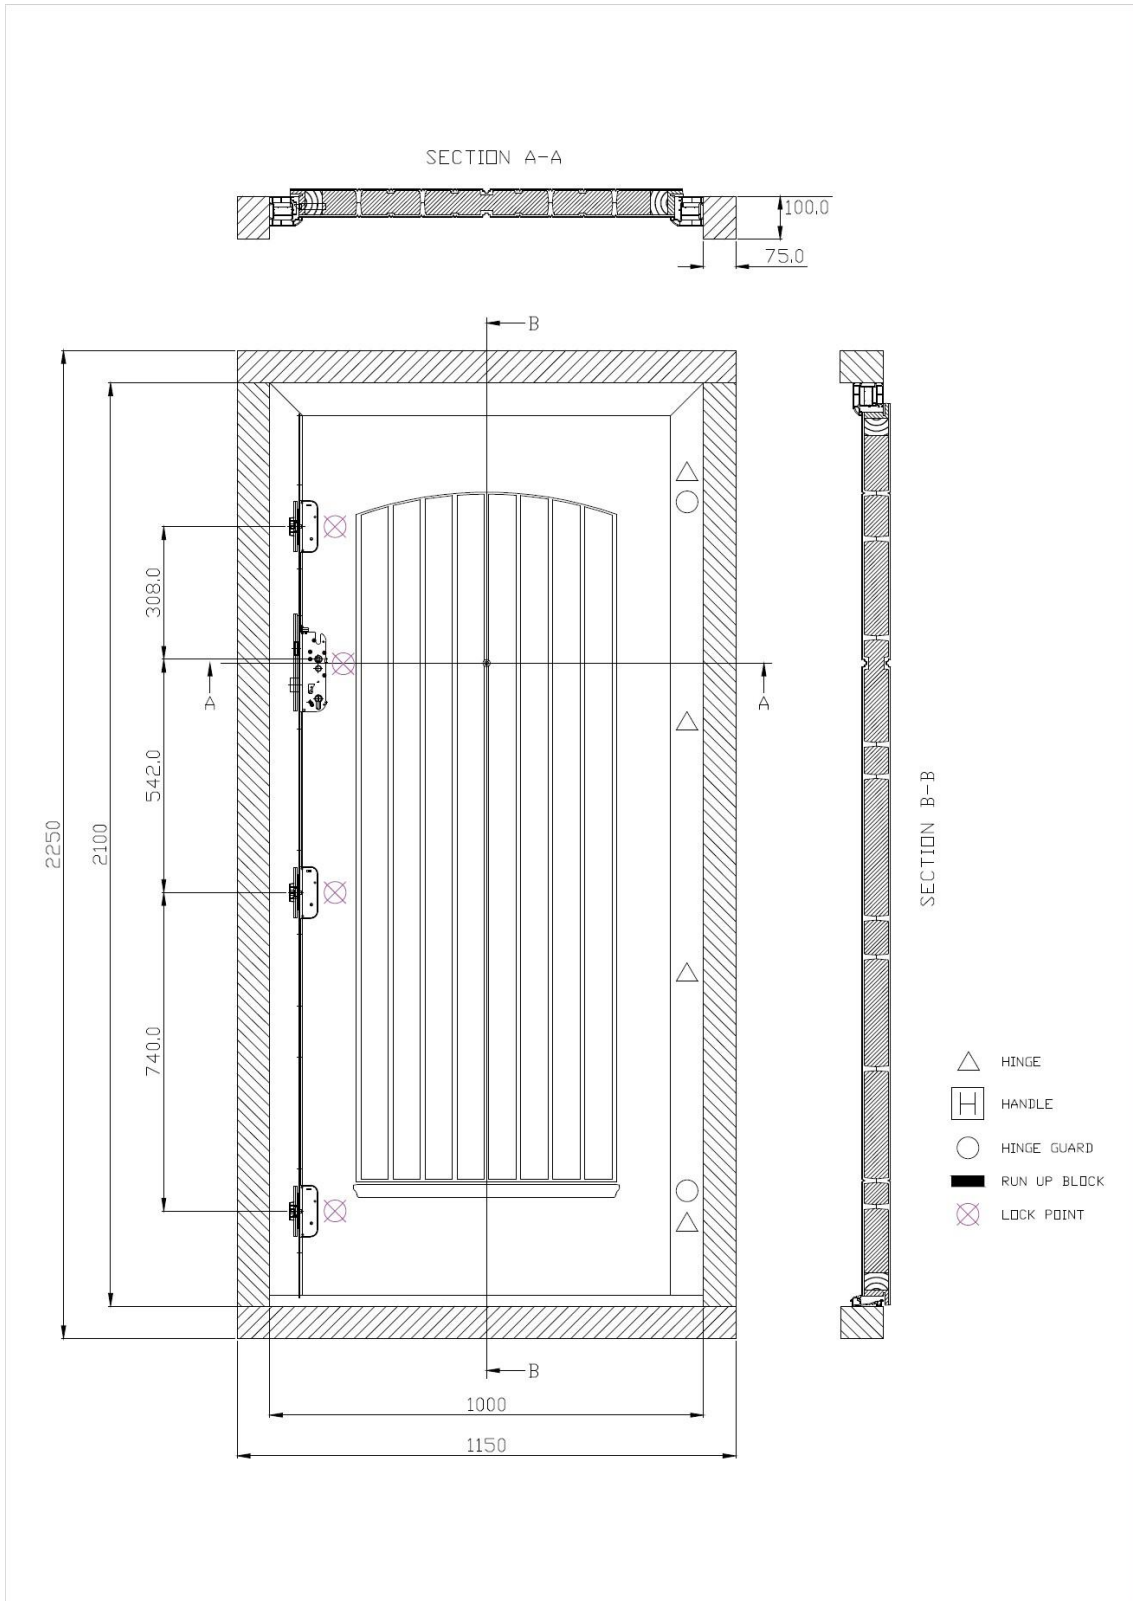
7. System Drawings

See Section 7 for test sample drawings as provided by the customer.
