Technical Report – R4791475629-3 PAS 24:2022 - Enhanced Security Performance Requirements for Doorsets and Windows in the UK

**Gretsch Unitas Ltd
Composite Door with GU Secury LogIQ
Automatic Hardware**

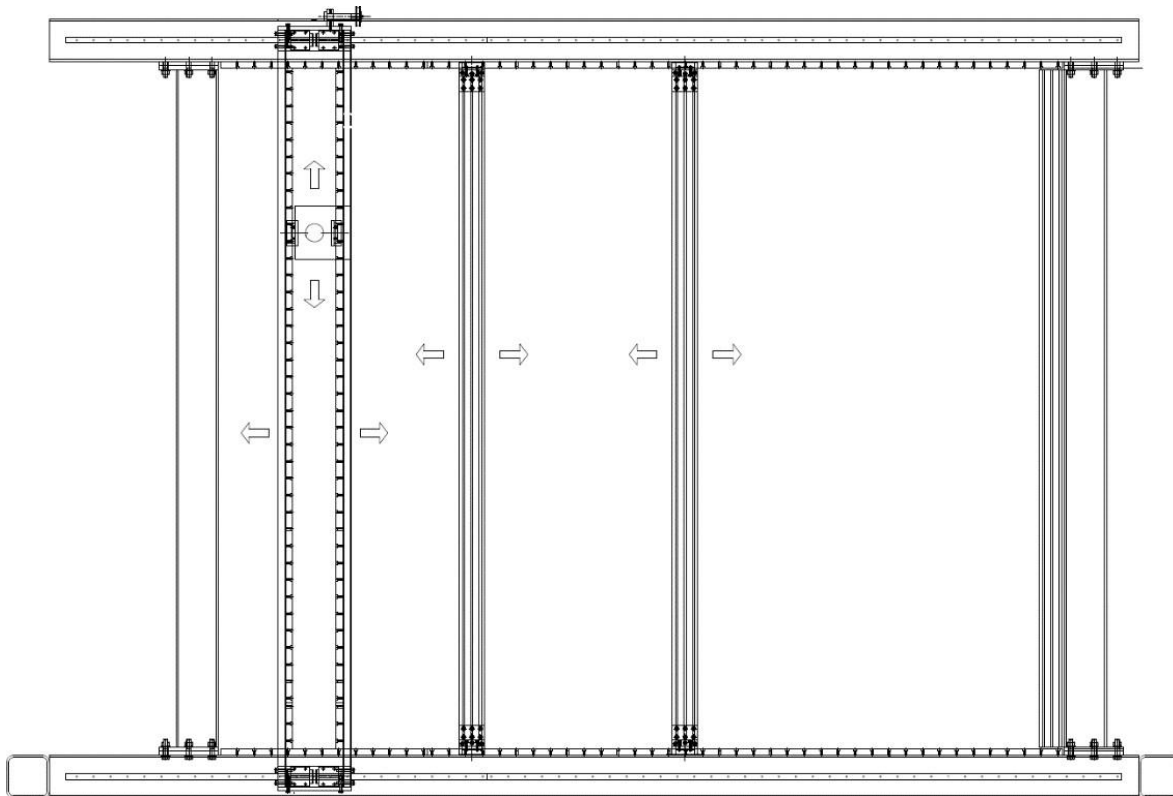
Figure 1 – Test rig used for testing

The test sample was supplied mounted in a 100 x 75 mm timber sub-frame in accordance with manufacturer's installation requirements. The sample was installed into the test rig, which was constructed to meet the requirements of the test specification, and was installed plumb, square and without twist or bends.

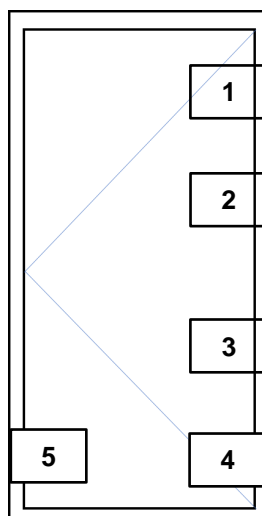
Figure 2 – Attack locations

Attempts were made from the external face to operate, release and disengage the system hardware to gain entry through the sample in accordance with section C.4.3 of PAS 24:2022. The results are as follows:

Location	Tools used	Method	Time	Entry gained
1. Shoot bolt	x2 Paint scrapers	Attacks were made with the two paint scrapers to try and manipulate the hardware open.	03:00	No
2. Dead bolt	x2 Paint scrapers	Attacks were made with the two paint scrapers to try and manipulate the hardware open.	03:00	No
3. Shoot bolt	x2 Paint scrapers	Attacks were made with the two paint scrapers to try and manipulate the hardware open.	03:00	No
4. Shoot bolt	x2 Paint scrapers	Attacks were made with the two paint scrapers to try and manipulate the hardware open.	03:00	No
5. Hinge	x2 Paint scrapers	Attacks were made with the two paint scrapers to try and manipulate the hardware open.	03:00	No

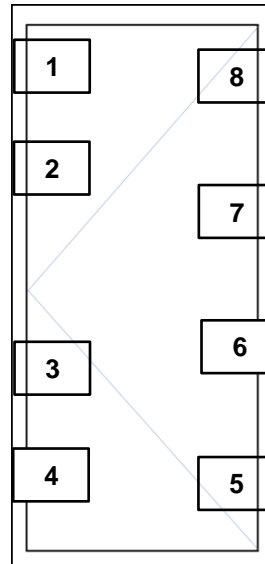
Figure 3 – Loading points

A series of loads were applied to the door leaf as defined in section B.4.5 of PAS 24:2022. The loading combinations used were as defined in table B.1 to table B.6 of PAS 24:2022 for the applicable door type and were applied as shown in table 2. The results are as follows:

Loading point	Parallel-to-plane load			Perpendicular-to-plane load			Result
	Targeted (kN)	Applied (kN)	Direction	Targeted (kN)	Applied (kN)	Direction	
1. Hinge / dog bolt	1.500	1.452	→	4.500	4.504	-	Pass
2. Hinge	1.500	1.504	→	4.500	4.488	-	Pass
3. Hinge	1.500	1.504	→	4.500	4.486	-	Pass
4. Hinge / dog bolt	1.500	1.525	→	4.500	4.522	-	Pass
5. Shoot bolt	1.500	1.504	→	4.500	4.488	-	Pass
6. Shoot bolt	1.500	1.502	←	4.500	4.502	-	Pass
7. Deadbolt	1.500	1.510	←	4.500	4.462	-	Pass
8. Shoot bolt	1.500	1.490	←	4.500	4.482	-	Pass

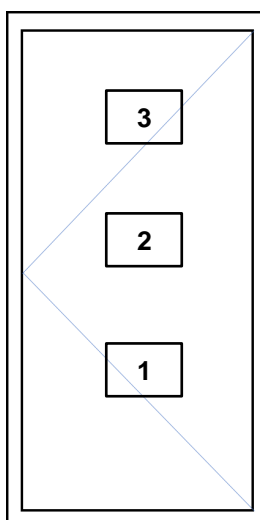
Figure 4 – Impact locations

The test sample was subject to soft body impacts on the external face as shown in figure 4. Each of the locations was subject to 3 impacts from a drop height of 800mm.

No damage was observed nor was entry gained during the test.
