# PAS 24:2022+A1:2024

**Product Tested:** Hendersons Bi-Folding Door 3+0 Outward Opening

**Report N°:** MTCR0492

Enhanced security performance requirements for Doorsets and Windows in the UK  
PAS 24:2022+A1:2024

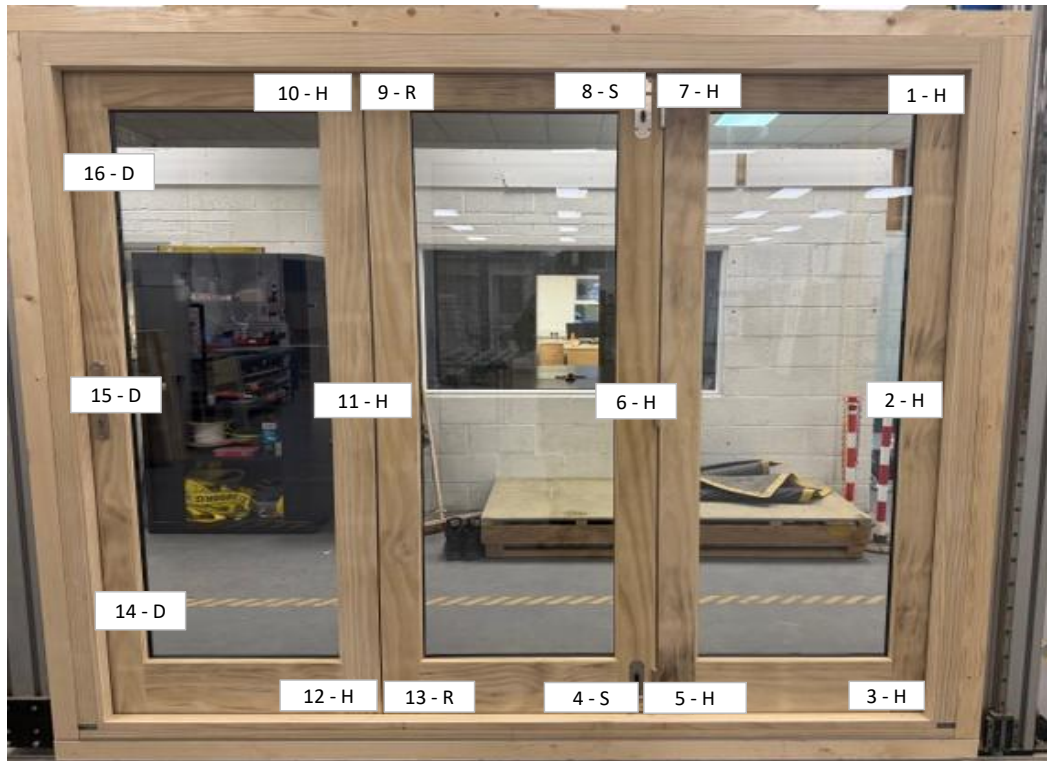
Figure 1. Photograph of test sample which indicates loading points and sequence

H = Hinge  
S = Shootbolt  
D = Deadbolt  
R = Roller

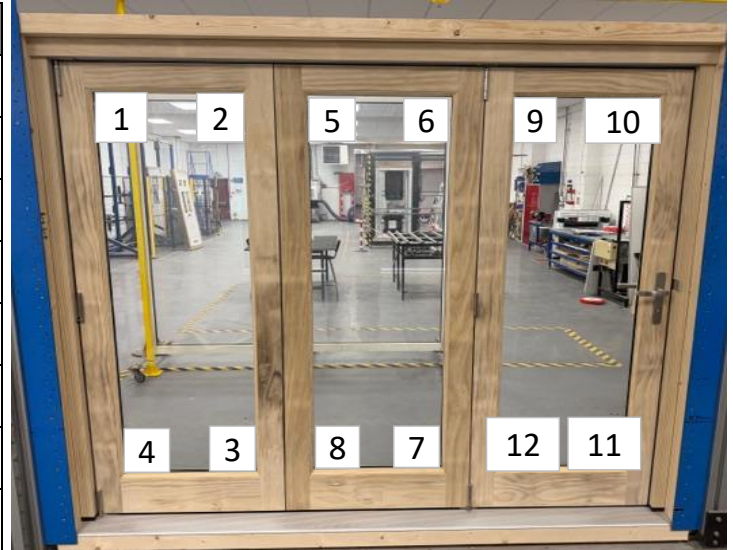
The sample was installed into the test rig square and true in accordance with B.3.1 and was tested in accordance with clause B.4.4.3 with loads of 2.0kN applied progressively, without shock to every corner of the glazing retention system. The objective of this test is to establish the strength and resistance to forces applied to the glazing with the view to pushing the glass out from the exterior face of the sample to gain entry.

Test Ref Point	Target Load	Actual Load	Result
1	2kN	2.05kN	PASS
2	2kN	2.07kN	PASS
3	2kN	2.08kN	PASS
4	2kN	2.10kN	PASS
5	2kN	2.03kN	PASS
6	2kN	2.04kN	PASS
7	2kN	2.03kN	PASS
8	2kN	2.02kN	PASS
9	2kN	2.01kN	PASS
10	2kN	2.11kN	PASS
11	2kN	2.06kN	PASS
12	2kN	2.04kN	PASS

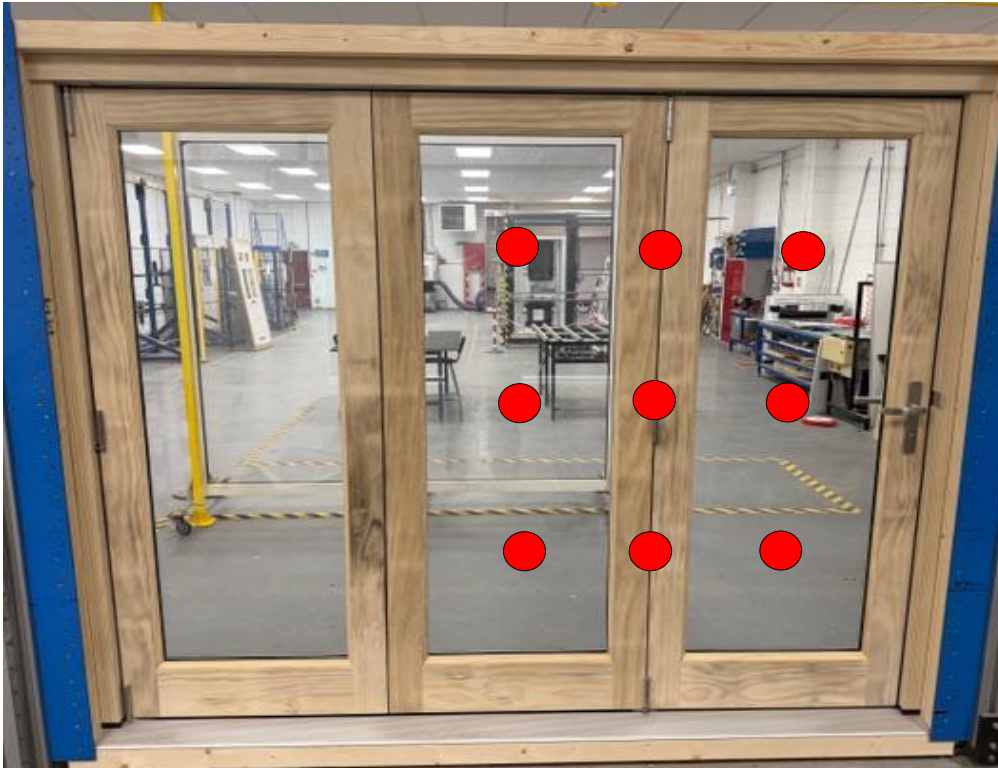
*Viewed from outside*

The sample was installed into the test rig square and true in accordance with B.3.1 and was tested in accordance with clause B.4.8 with all impact positions defined by the style of sample submitted. The objective of this test is to assess the doorset's resistance to impacts using a soft body by striking each impact point 3 times from the exterior face of the door leaf at 0.8m, and 1.7m above floor level.

● = Impact locations

1 = 0.8m

2 = 1.25m

3 = 1.7m

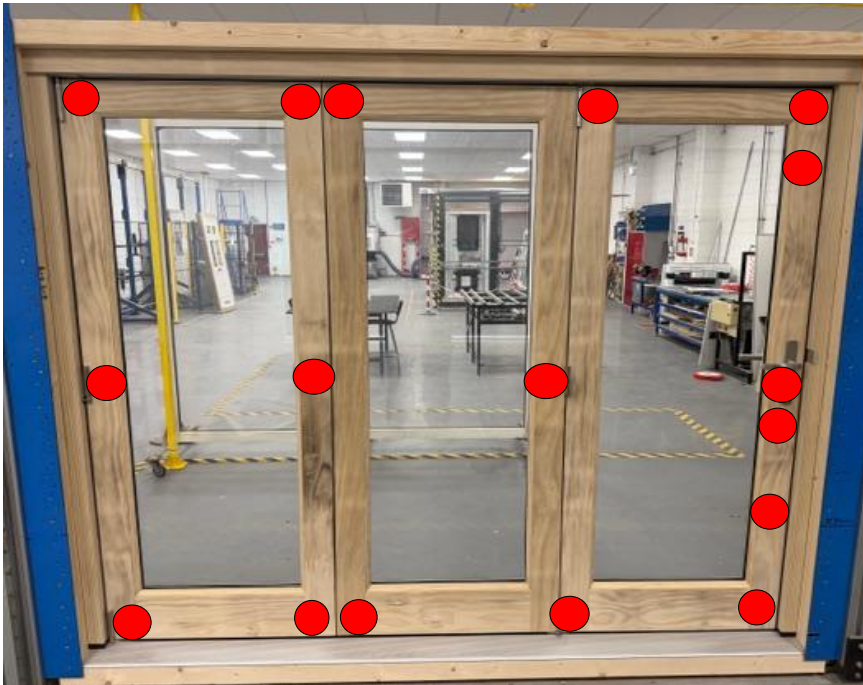
Viewed from outside - Impact sequence starts from top corner on the hinge side.

The sample was installed into the test rig square and true in accordance with B.3.1 and was tested in accordance with clause B.4.9.2.2 with all impact positions defined within this clause. The objective of this test is to assess the doorset's resistance to impacts using a hard body by striking each impact point 3 times from the exterior face of the door leaf.

= Impact locations on door leaf

- 1 - Top Corner/ Hinge
- 2 - Middle Hinge
- 3 - Bottom Corner/ Hinge
- 4 - Corner/ Hinge
- 5 - Corner/ Shootbolt
- 6 - Hinge
- 7 - Corner/ Hinge
- 8 - Corner/ Shootbolt
- 9 - Corner/ Roller
- 10 - Hinge
- 11 - Corner/ Roller
- 12 - Corner
- 13 - DeadBolt
- 14 - Deadbolt
- 15 - Cylinder
- 16 - Dead bolt
- 17 - Corner
